TRANSMITTAL OF THE TOP 20 ENVIRONMENTAL RESTORATION FACT SHEETS -
TGH-339-95

FACT SHEET FOR TOP 20 ENVIRONMENTAL SITES
IHSS 121, 126.1, 126.2, TANK T-8

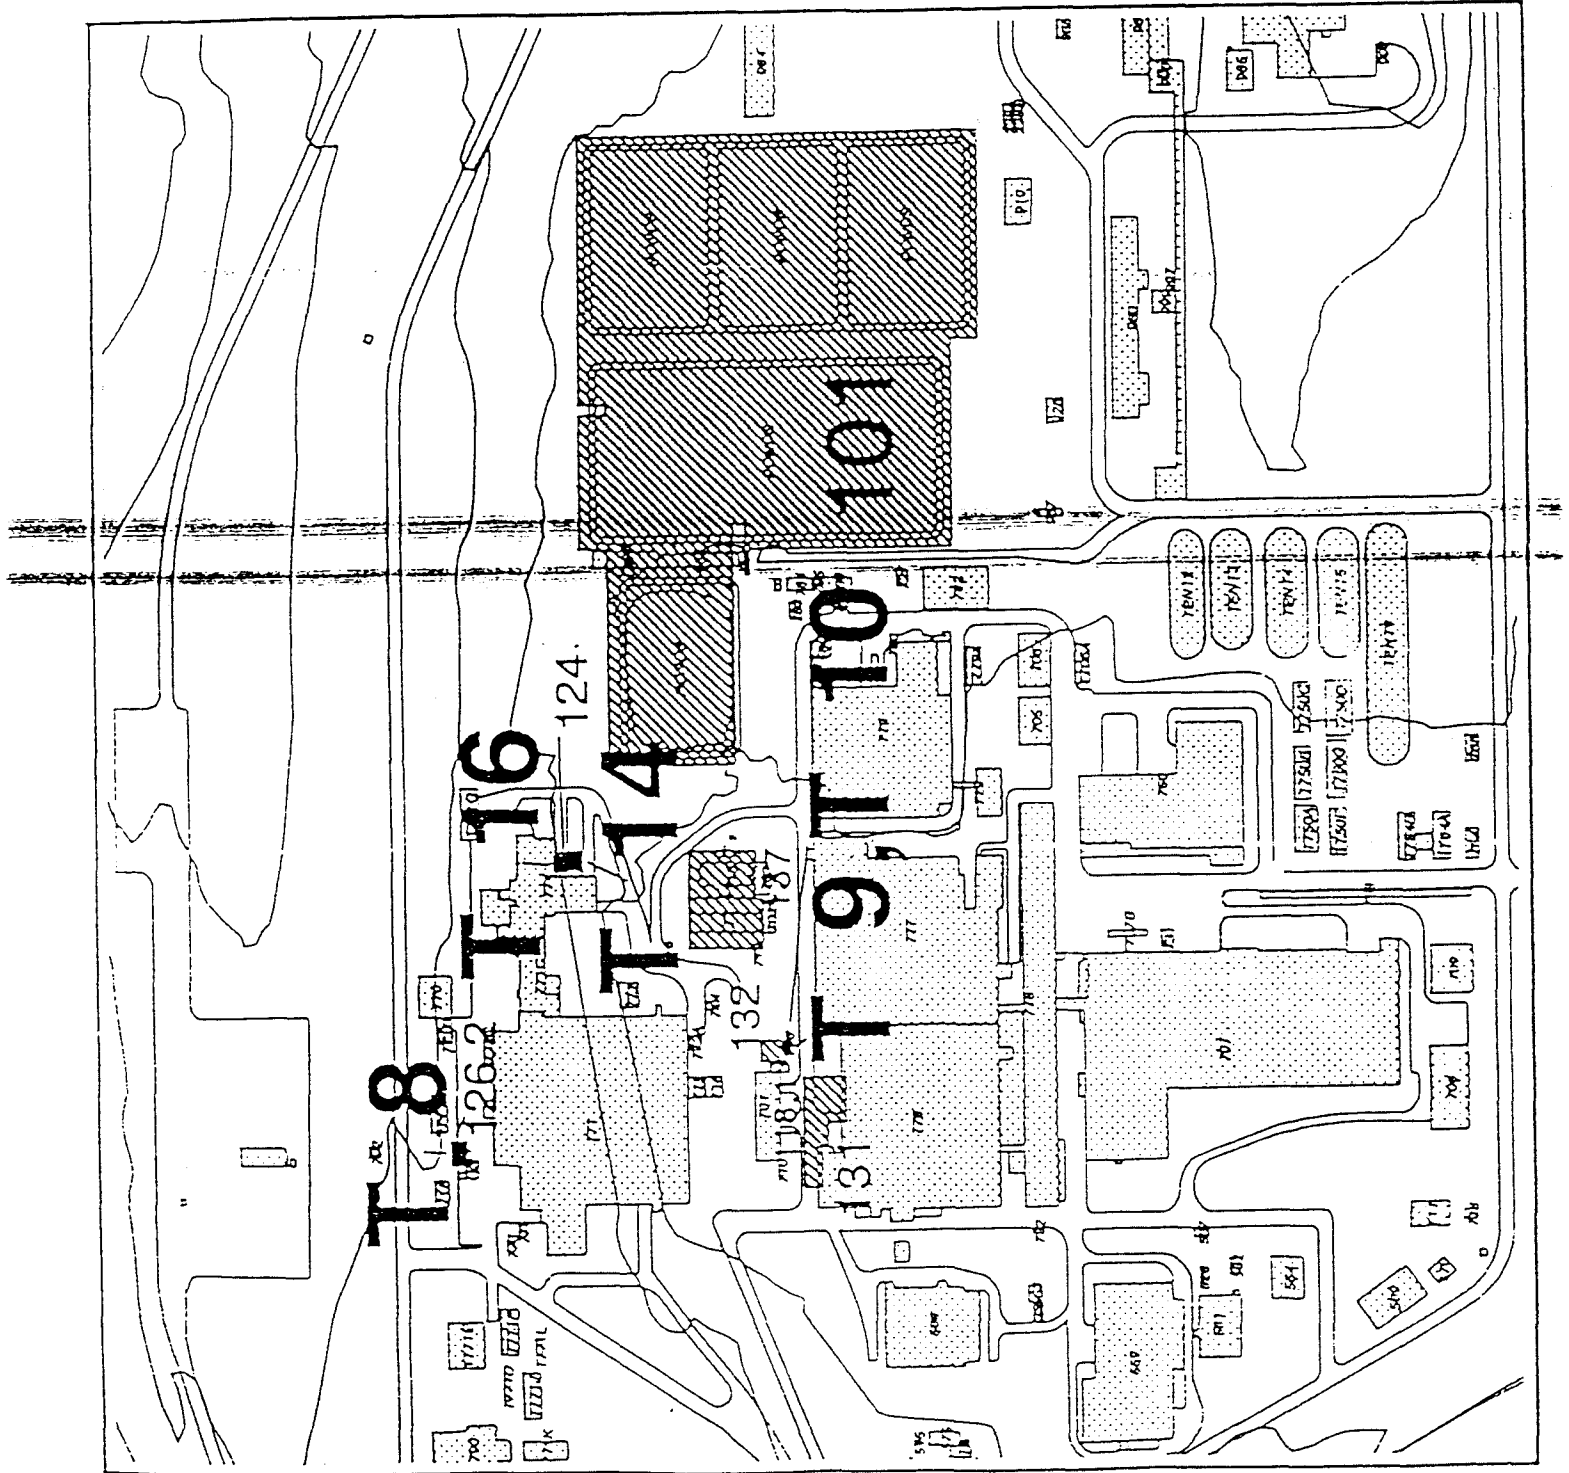
- 1 - 121/124 Tank T-14
- 2 - 118.1, 132 and 121 Tanks 9&10
- 3 - 121/124.1/124.2/125 PW Tank T-16H
- 13- 131 Rad Site II
- 15- 137 Bldg 712/713 Cooling T Blowdown
- 17- 101 Solar Ponds
- 19- 121, 126.1, 126.2, Tank T-8
